SNAP-8 TOPICAL MATERIALS REPORT FOR 1962

VOL. III - SNAP-8 MERCURY CORROSION AND MATERIALS RESEARCH

SNAP-8 MERCURY CORROSION AND MATERIALS RESEARCH

Topical Report

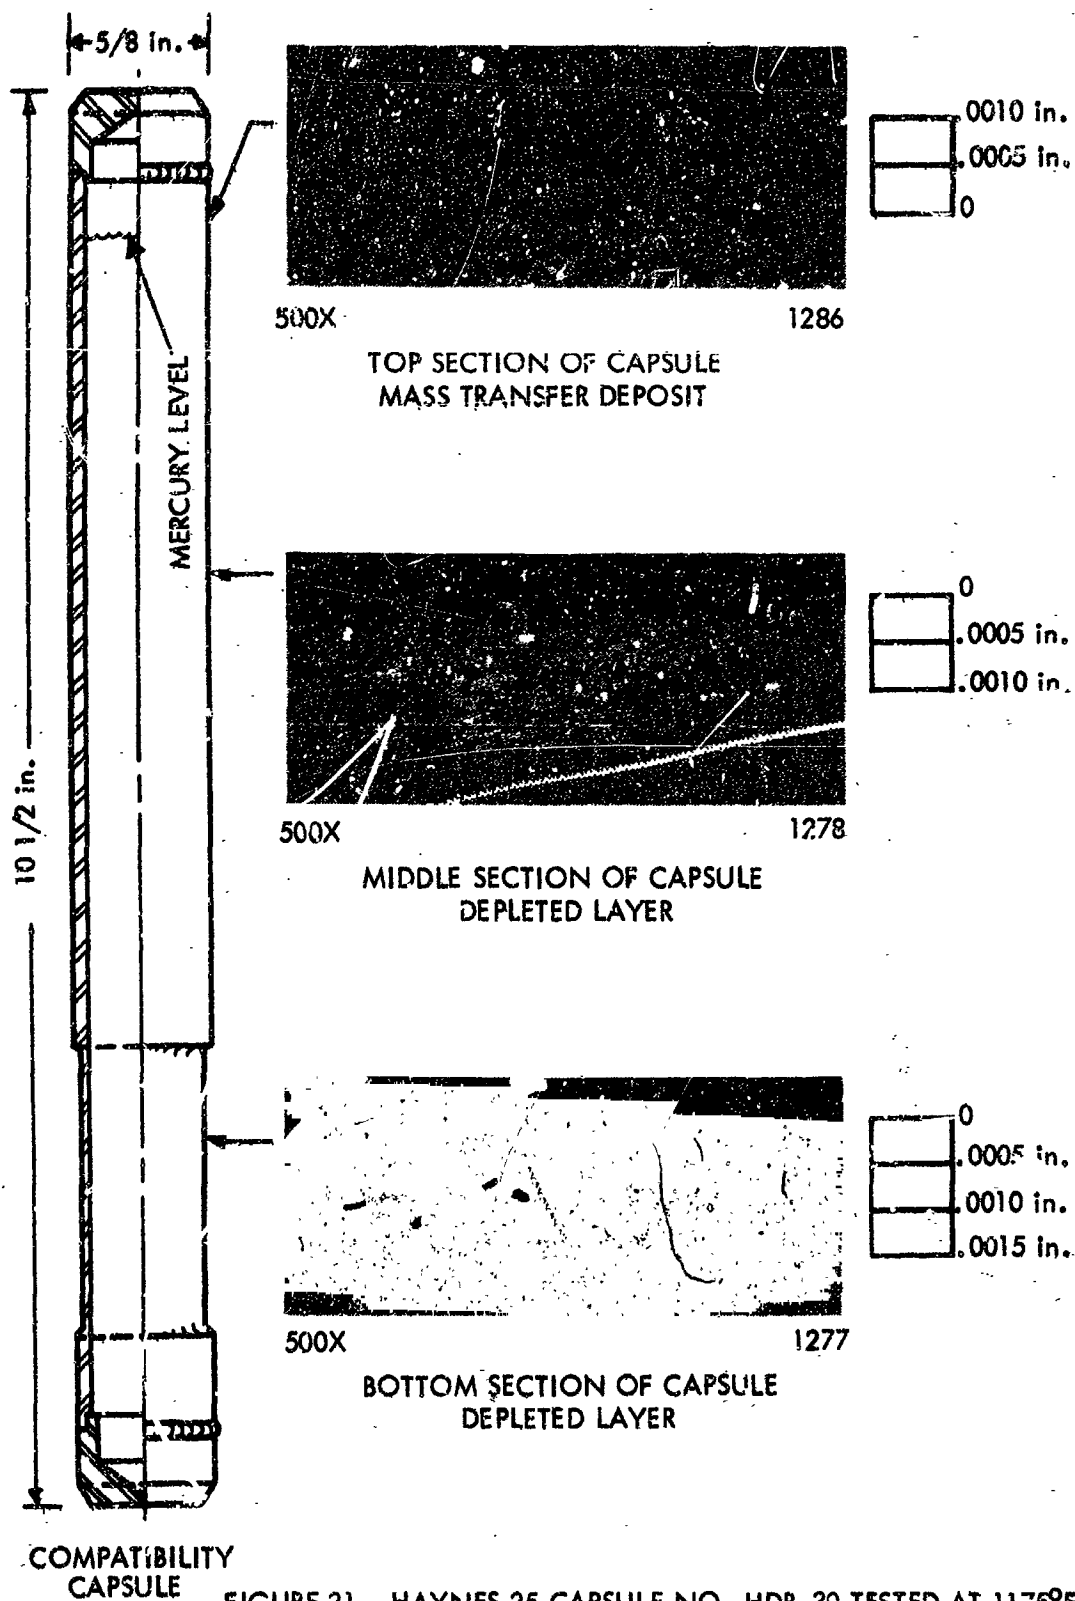
This capsule showed the same pattern found in the 2000 hour 1025°F capsule, except that the depleted layer apparently was spalled in some places. Also, the depleted layer did not graduate into the mass transfer deposit but continued along under the deposit for a distance of about three inches. The largest crystals were approximately 0.0015 in. in maximum dimension. Typical photomicrographs are shown in Figure 21.

FIGURE 21. HAYNES 25 CAPSULE NO. HDB-30 TESTED AT 1175°F FOR 2000 HOURS

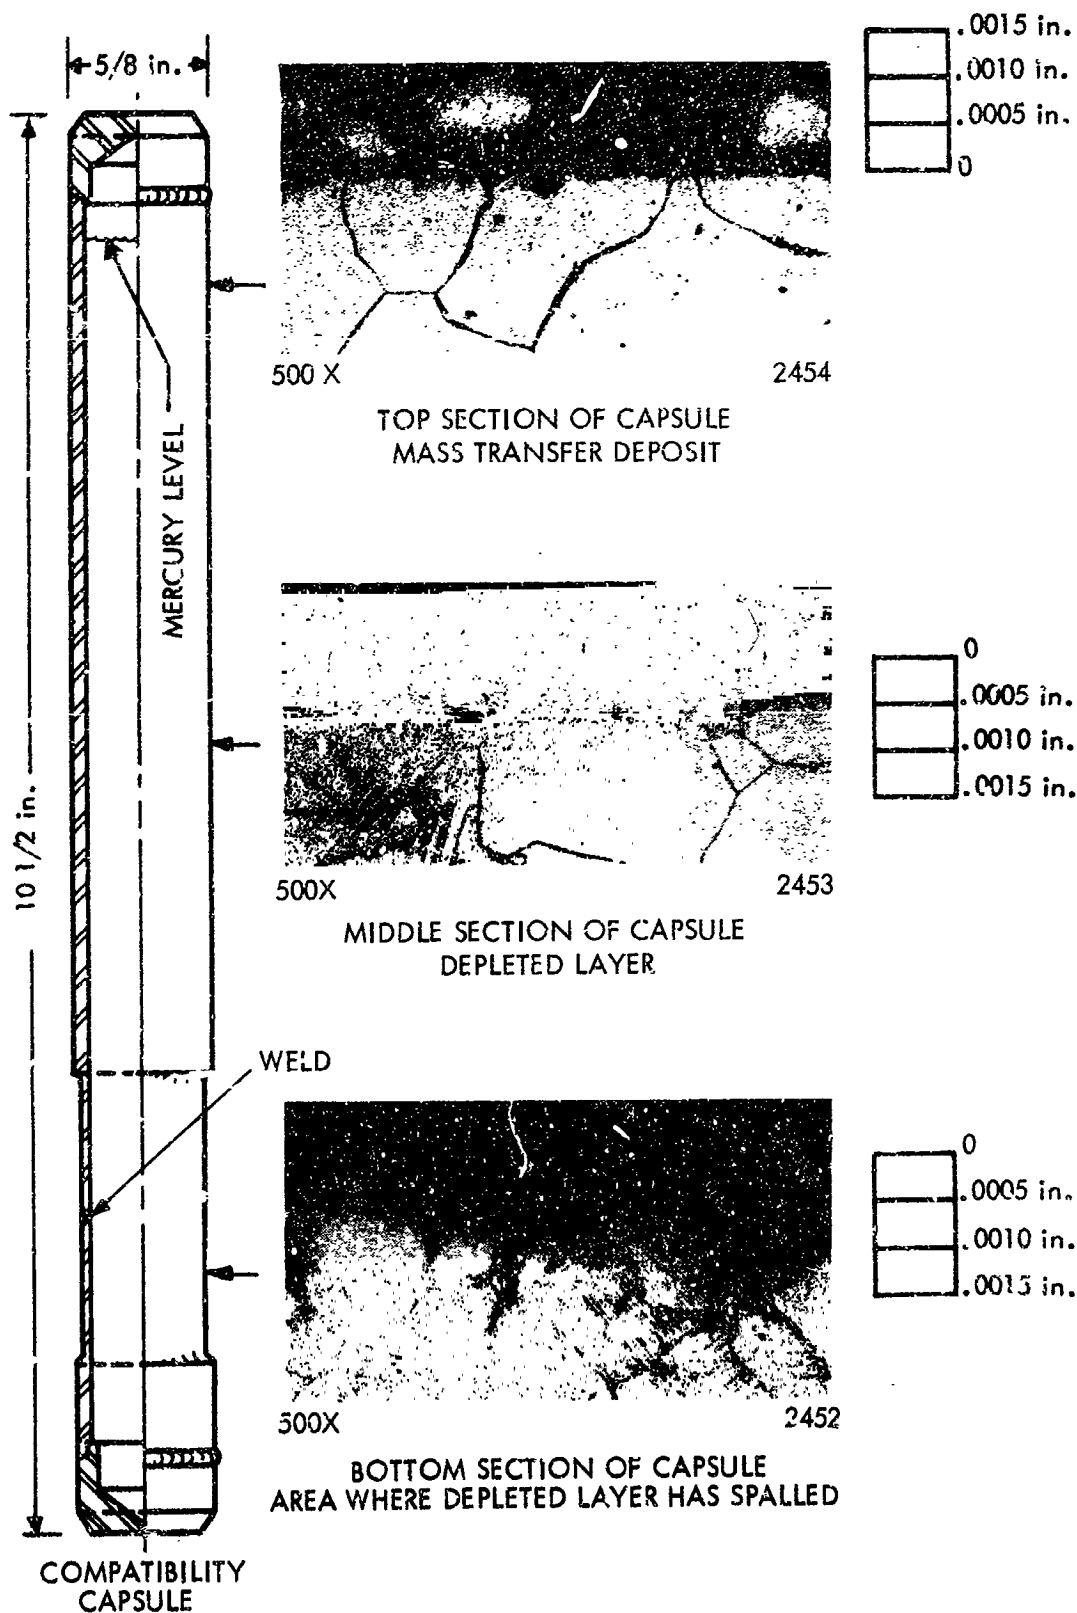
The depleted layer found near the bottom of the capsule had spalled in several areas (See Figure 22). The depleted layer extended down in small V-shaped areas in what appeared to be intergranular attack. The intergranular attack did not appear to advance rapidly, however, but stayed just ahead of the depleted layer. A depleted layer was found along the entire length of the capsule, extending under the mass transfer deposit at the top. Spalling of the depleted layer took place only in the bottom of the capsule where the temperature was highest.

FIGURE 22. HAYNES 25 CAPSULE NO. HDBW-37 TESTED AT 1175°F FOR 5000 HOURS

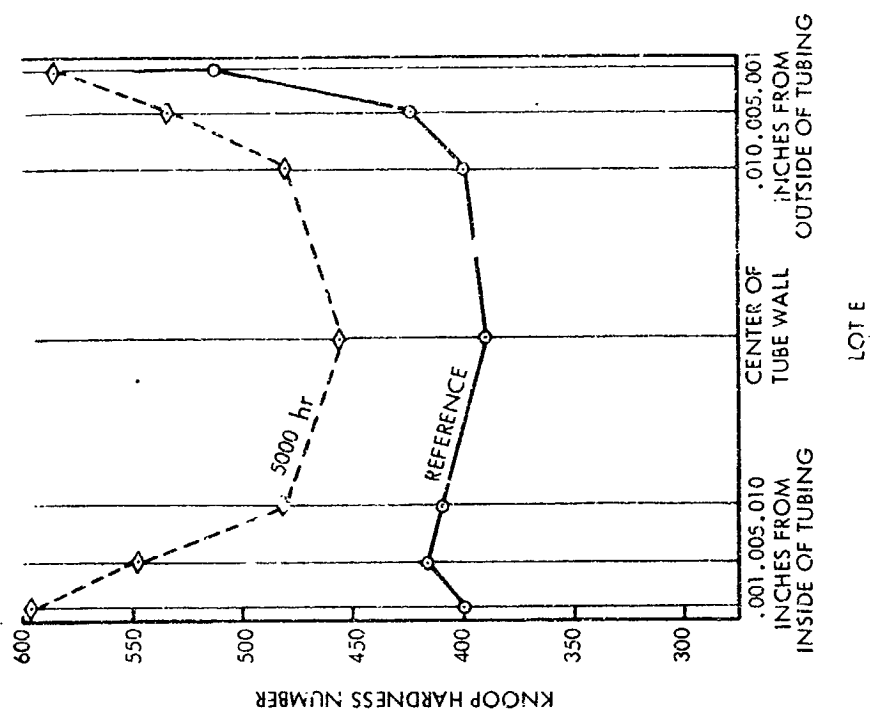
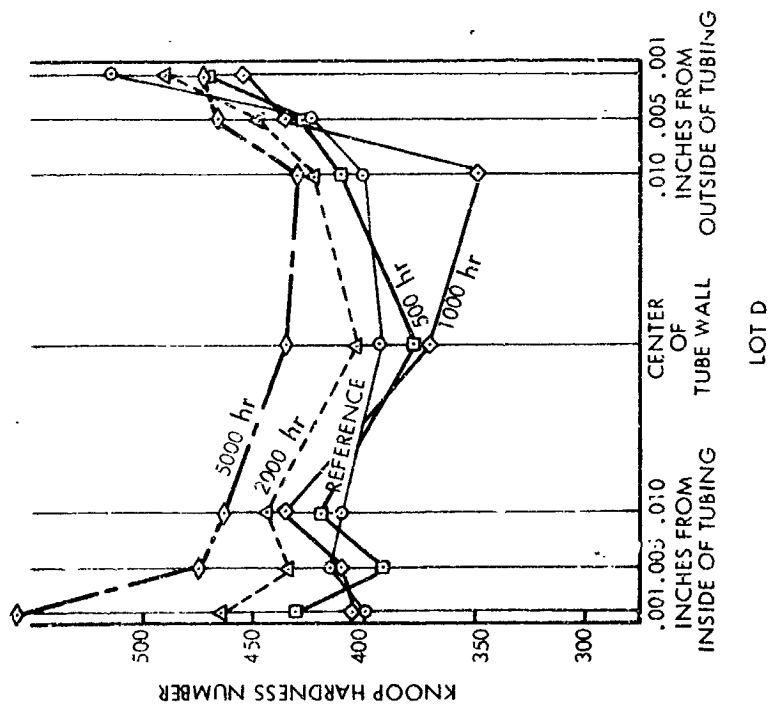
FIGURE 23. MICROHARDNESS SURVEY, HAYNES 25 EXPOSED TO MERCURY AT 1175°F

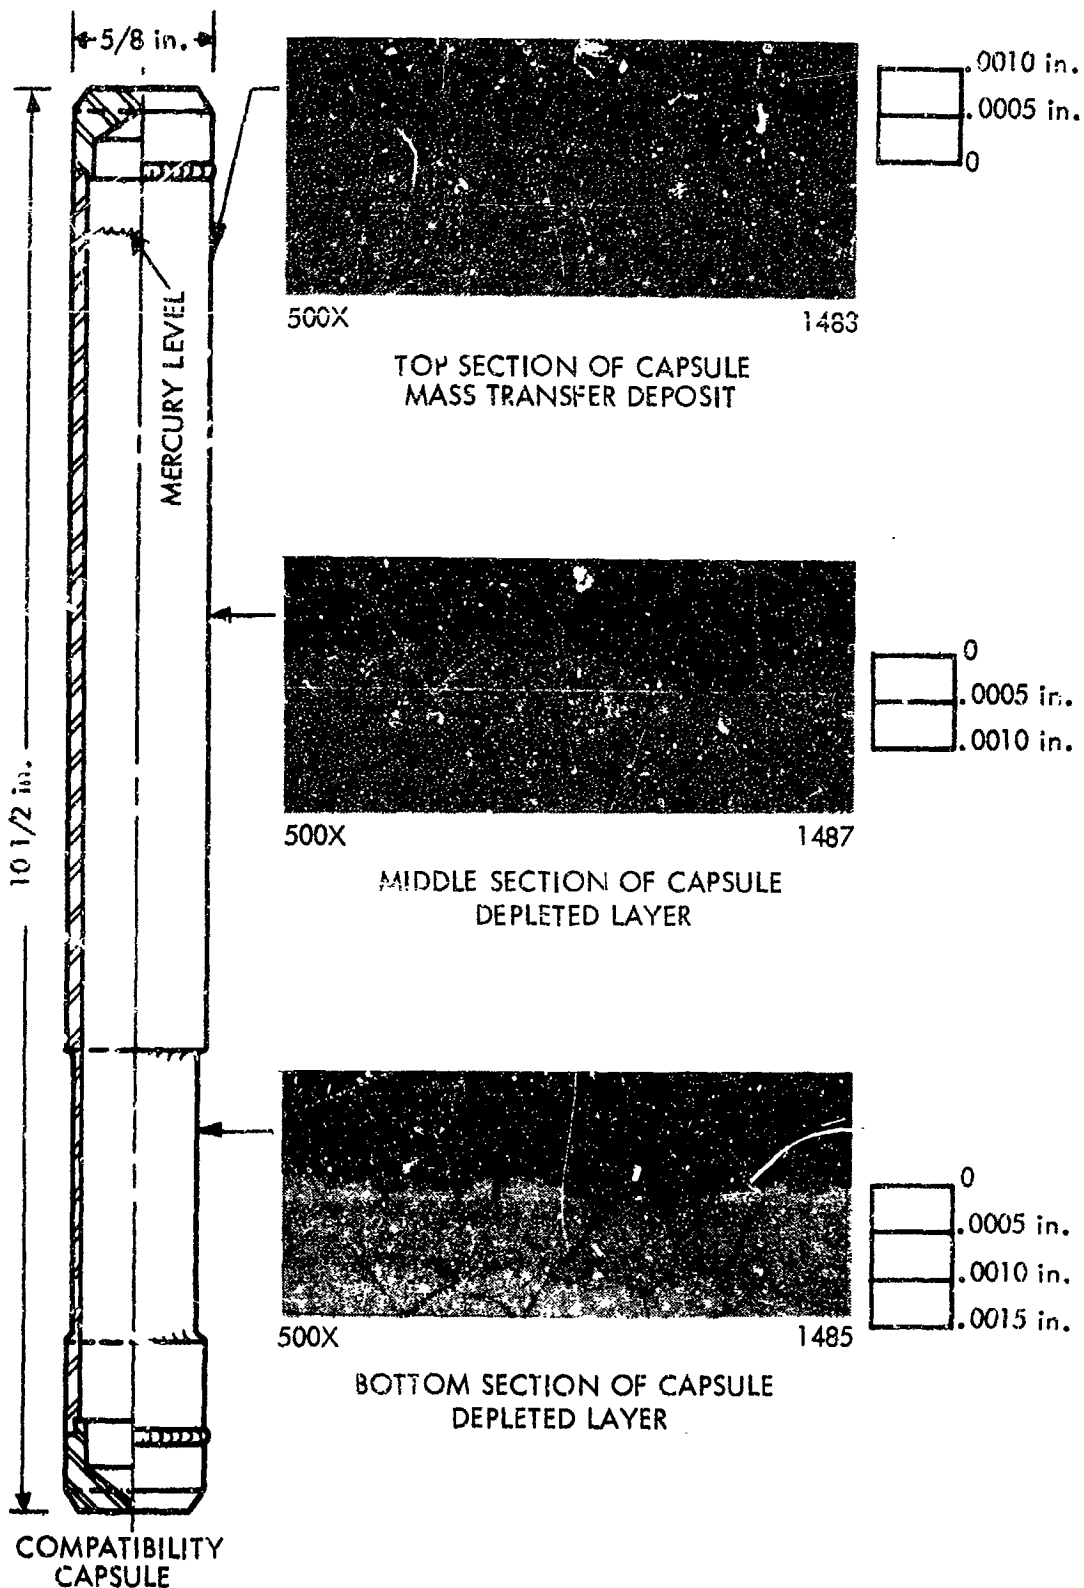
The same pattern as in the 1025°F, 2000 hour capsule was again found, however, almost complete spalling of the depleted layer appeared to have occurred. A mass transfer deposit was evident over 2½ square inches near the top of the capsule. The mass transfer deposit appeared to be more dense than the deposits observed in the 1025°C and 1175°F capsules. The greatest thickness of the mass transfer layer was 0.0006 in. Typical photomicrographs are shown in Figure 24.

FIGURE 24. HAYNES 25 CAPSULE NO. HDA-42 TESTED AT 1250°F FOR 1000 HOURS

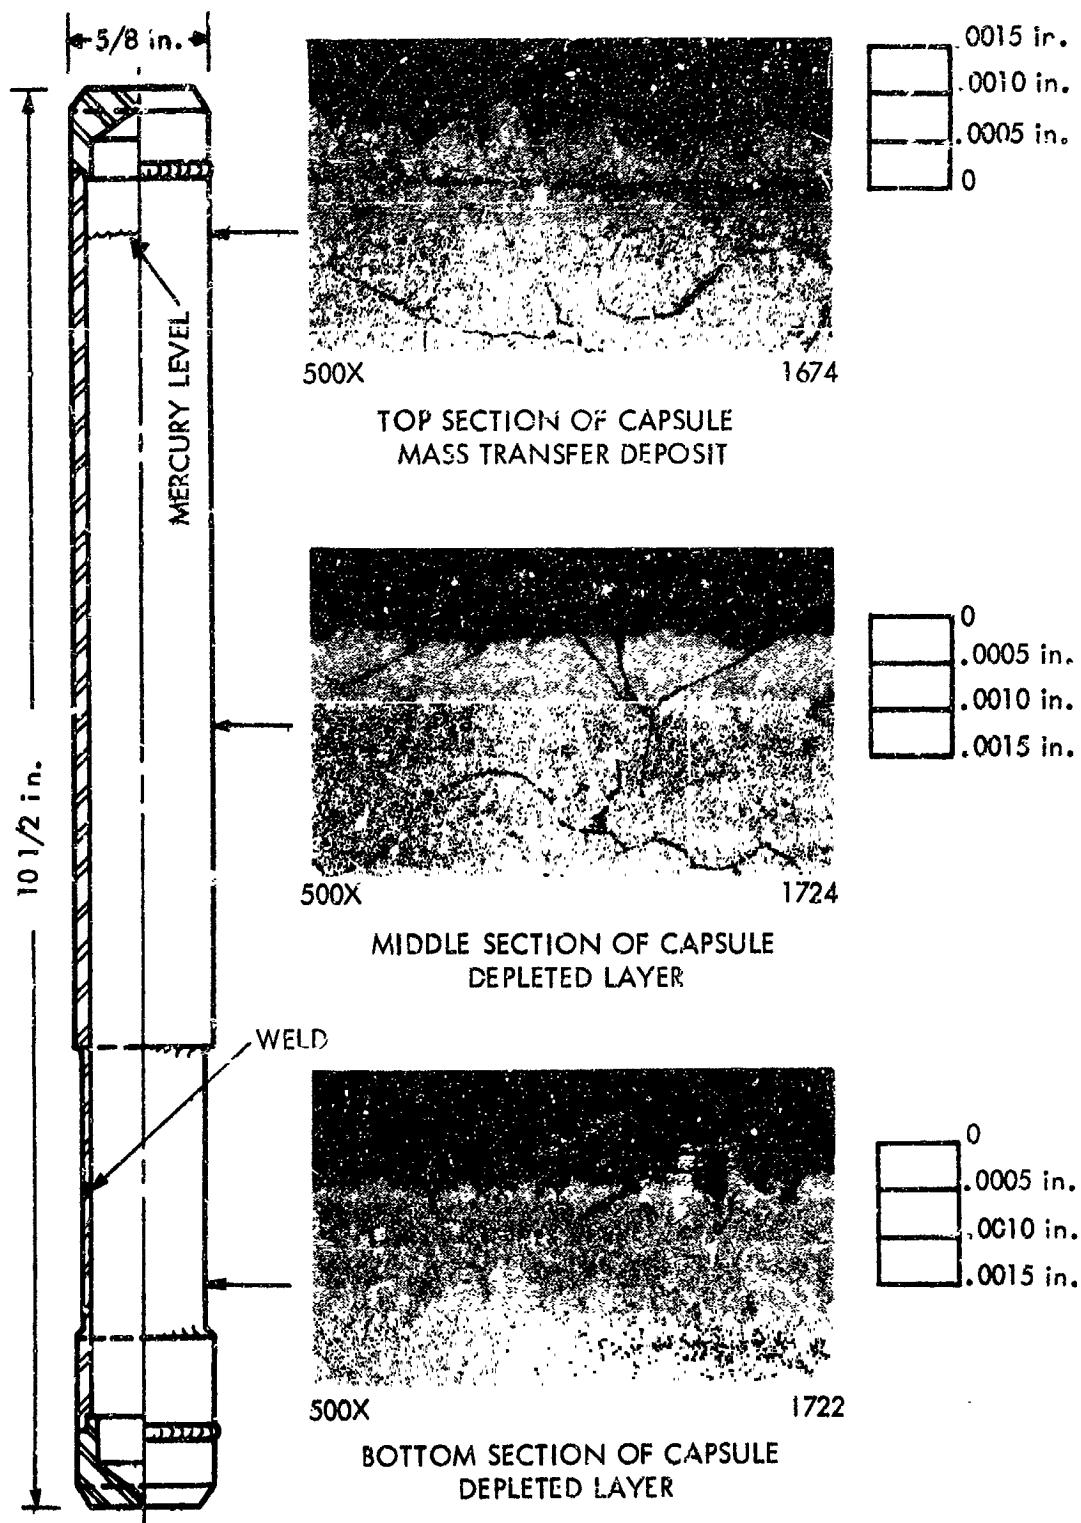
The depleted layer found along the length of the capsule was thinner than in the capsules exposed at lower temperatures, again indicating almost complete spalling. The depleted layer extends down in small V-shaped areas before the overall surface is attacked. Figure 25 shows a typical section of this corrosion pattern. The attack did not appear to be entirely intergranular. The mass transfer deposit was similar to that found in the capsules exposed at lower temperatures except that it was more dense and the depleted layer continued under the deposit.

FIGURE 25. HAYNES 25 CAPSULE NO. HDBW-46 TESTED AT 1250°F FOR 2000 HOURS

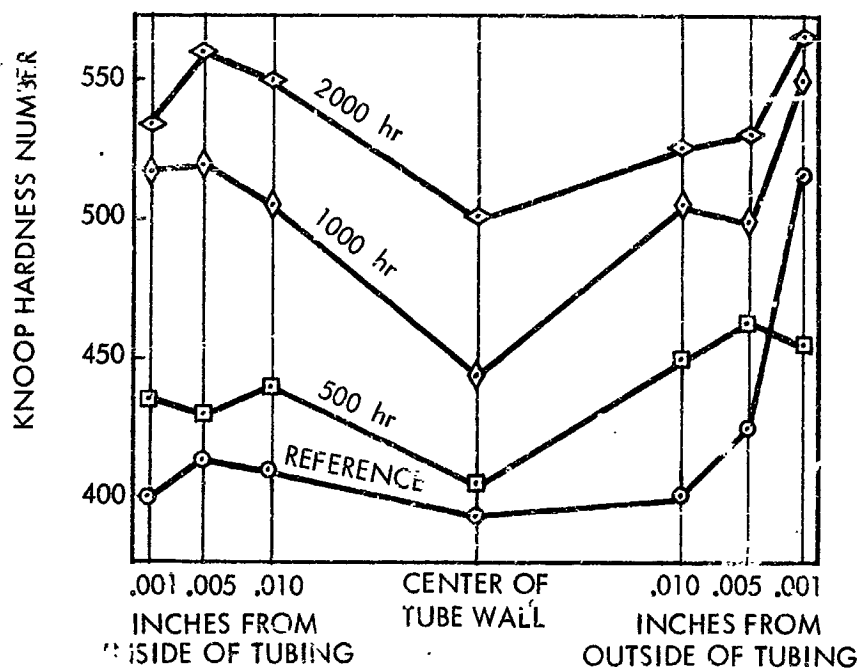
FIGURE 26. MICROHARDNESS SURVEY, HAYNES 25 L01 D EXPOSED TO MERCURY AT 1250°F

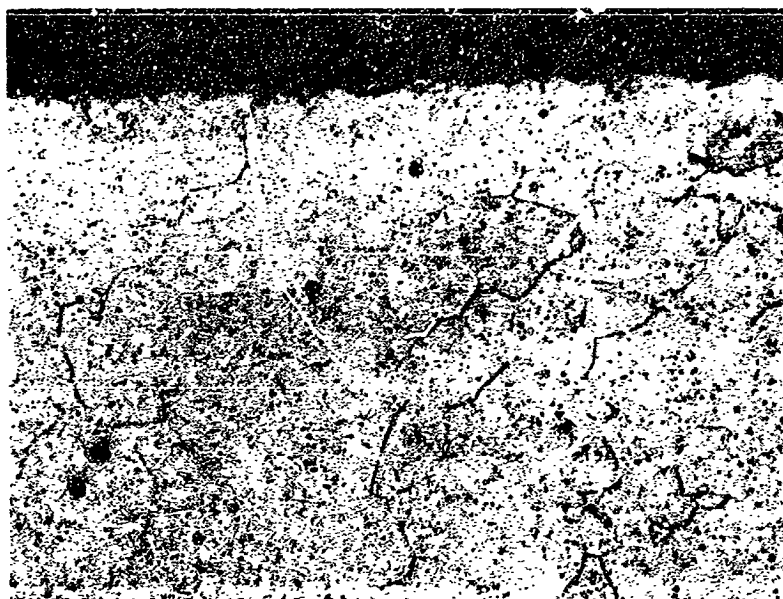
No corrosion layer of any type was found on the Type 405 stainless steel capsule exposed for 5000 hours at 1025°F. A mass transfer deposit was formed at the top of the capsule, indicating that an even solution attack must have taken place. Figure 27 shows a typical microstructure of the inside of the capsule.

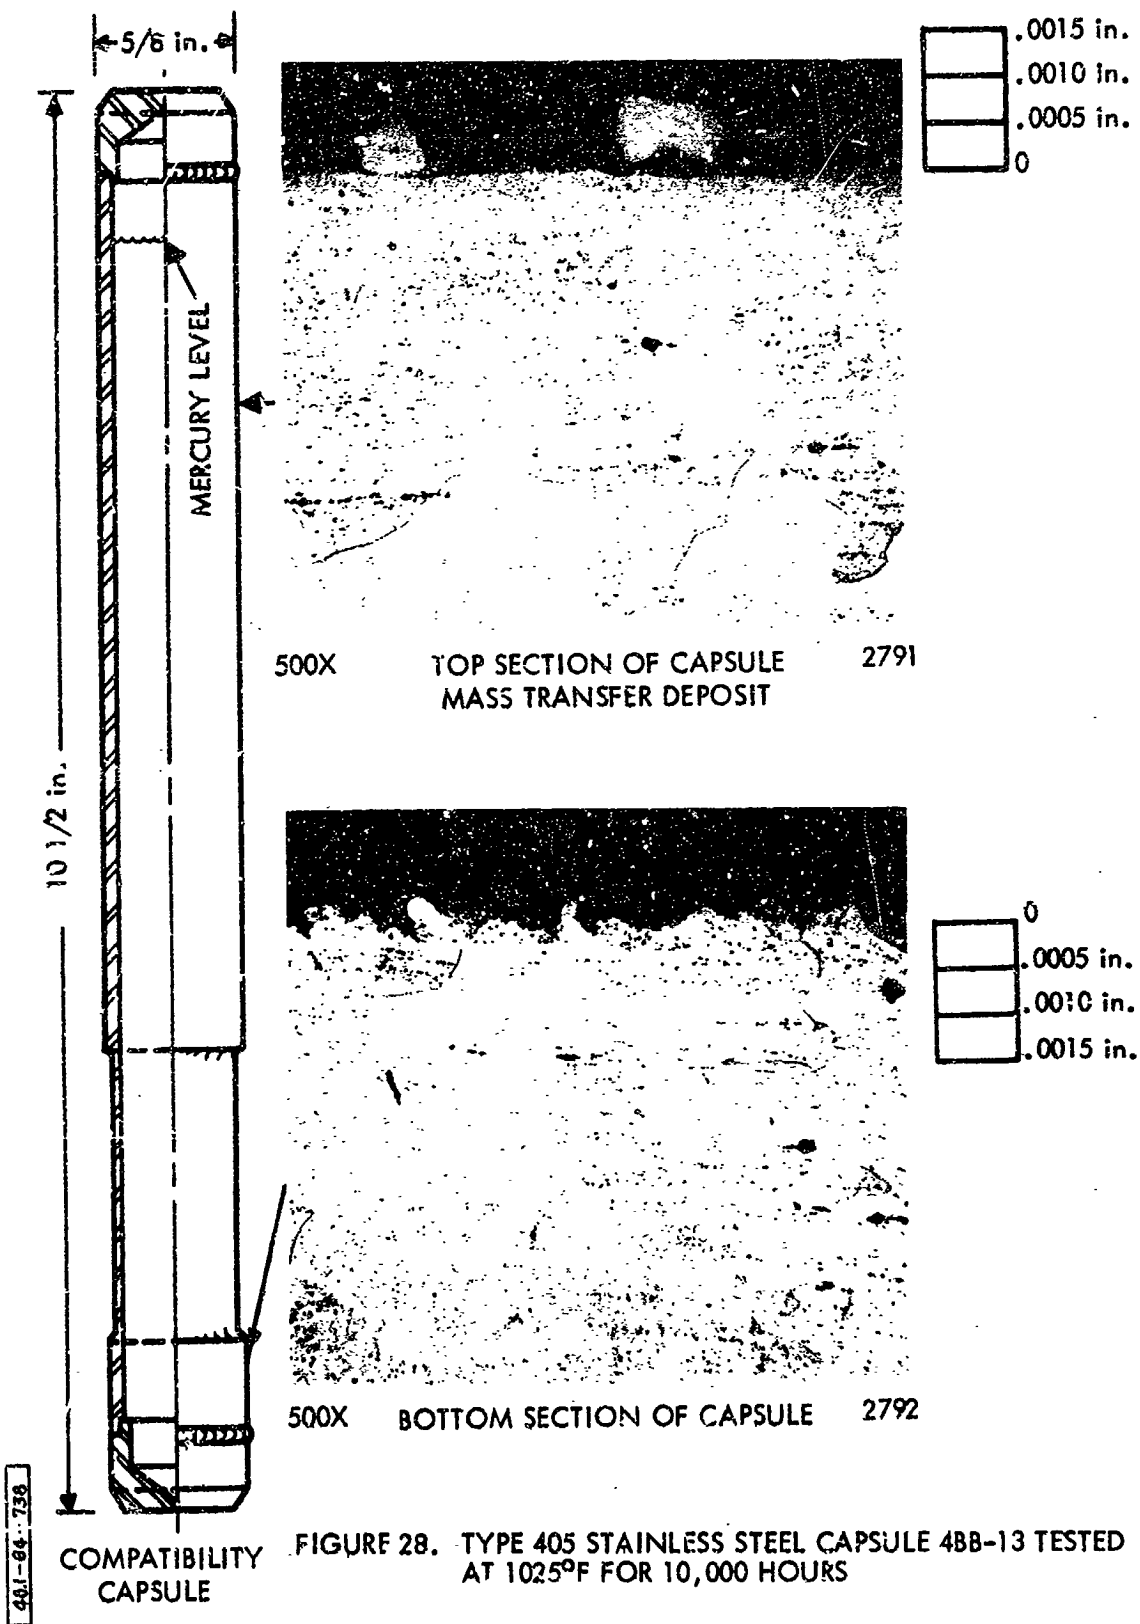
The microstructures of typical sections of the inside surface of this capsule are shown in Figure 28. A slight mass transfer deposit was formed at the top, or coolest, part of the capsule, but it was much less than that formed in the 10,000 hour, 1025°F Haynes 25 capsule. No depleted layer was formed on the bottom section of the capsule, indicating that solution attack of the entire wall had taken place rather than selective leaching of individual constituents.

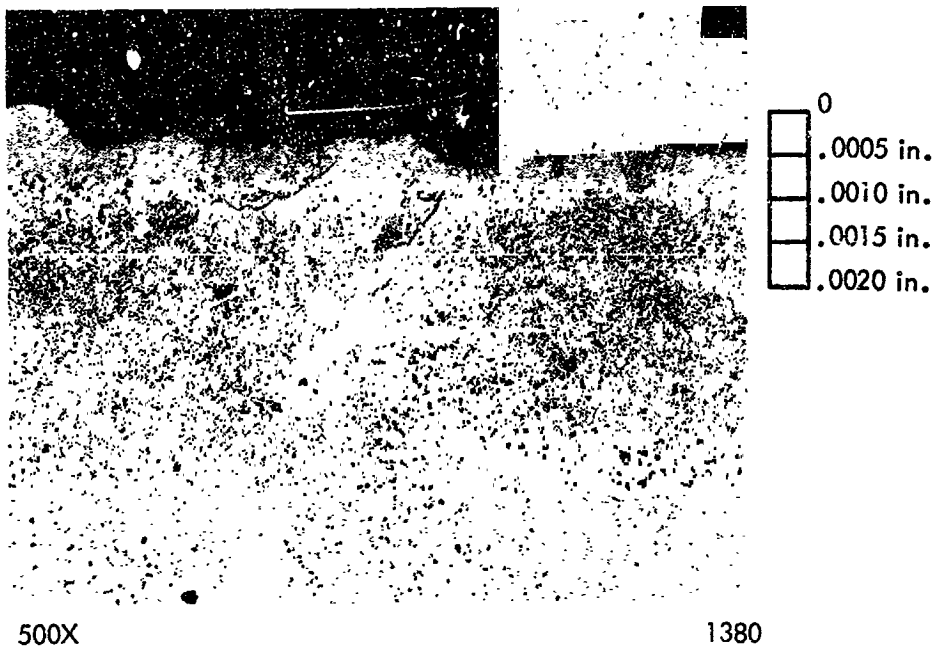
No corrosion layer was found. A slight roughening of the surface occurred but no intergranular penetration occurred. Figure 29 shows a typical microstructure from the capsule exposed for 5000 hours at 1100°F.

BOTTOM SECTION OF CAPSULE
 APPROXIMATELY 1/2 IN. FROM THE WELD

FIGURE 29. TYPE 405 STAINLESS STEEL CAPSULE NO. 4BA-4 TESTED
 AT 1100°F FOR 5000 HOURS

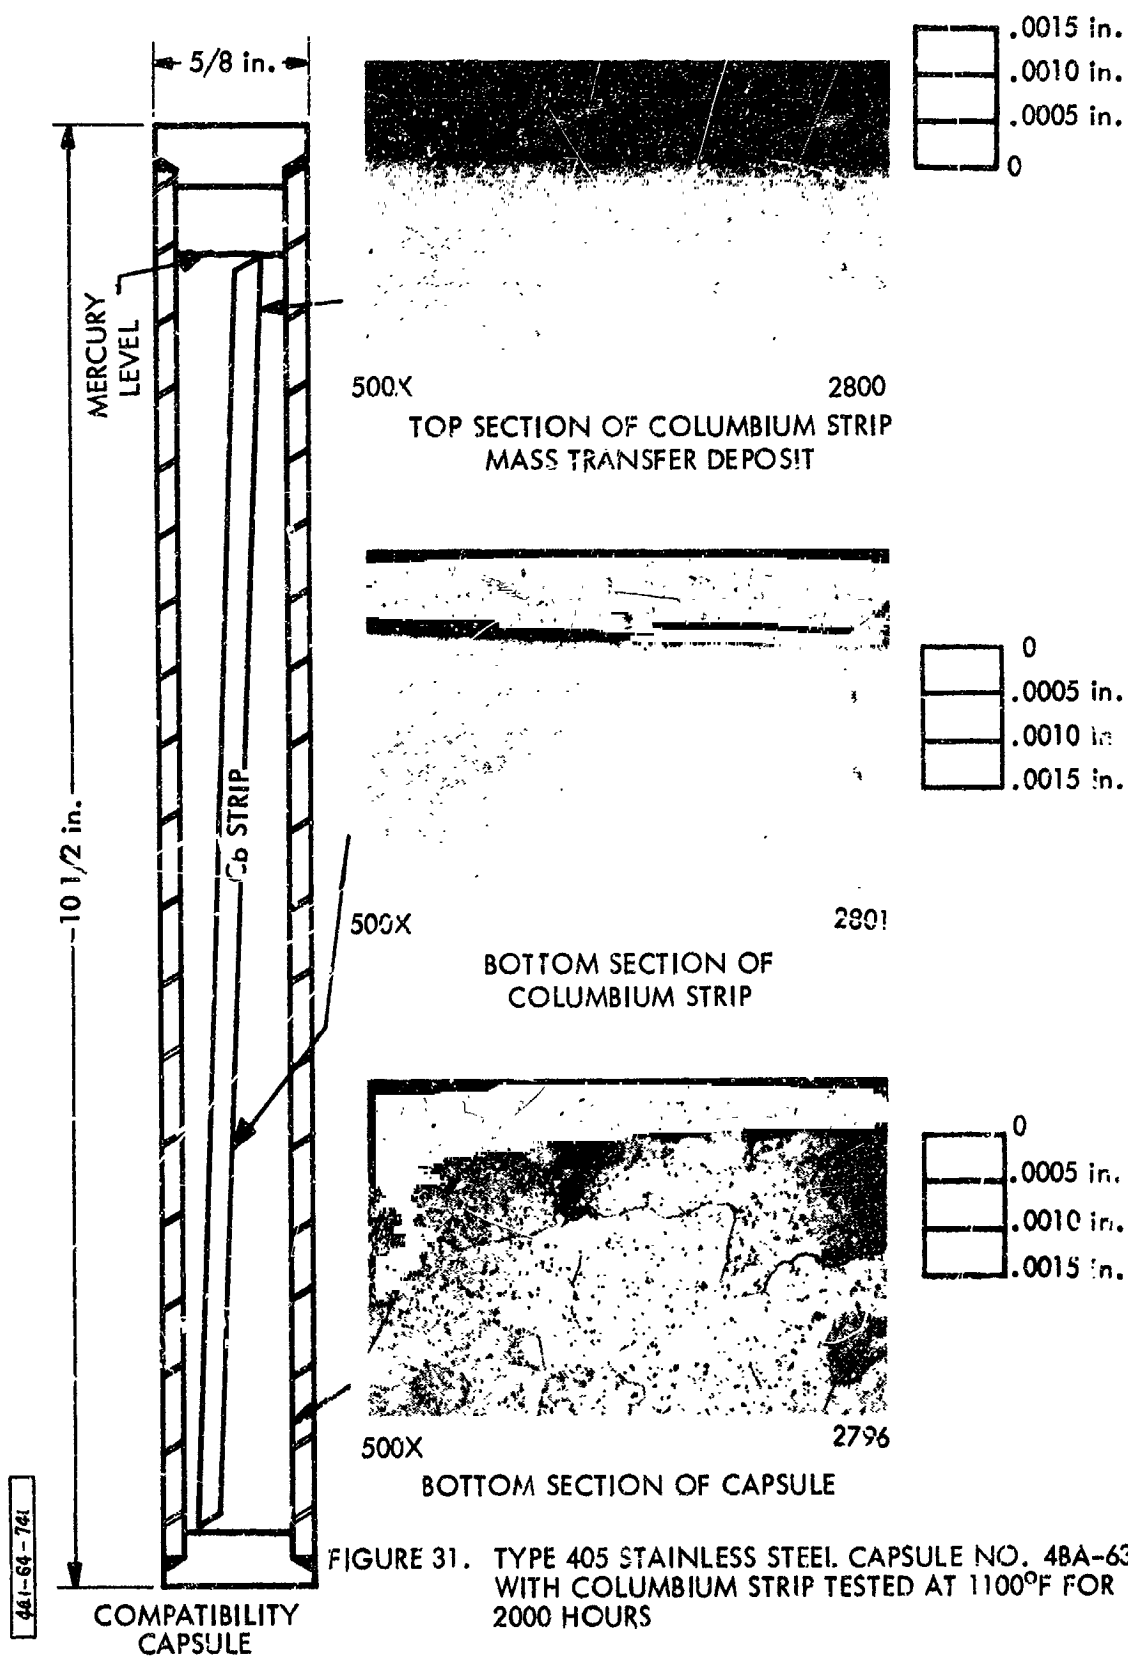
This capsule contained a columbium strip inside the capsule to test for bimetallic effects when Cb and Type 405 stainless steel are exposed to Hg. Figure 31 shows the position of the columbium strip in the capsule and typical microstructures of the strip and the capsule wall.

Microhardness measurements on the top and bottom of the columbium strip after exposure indicated that there was no change in hardness.

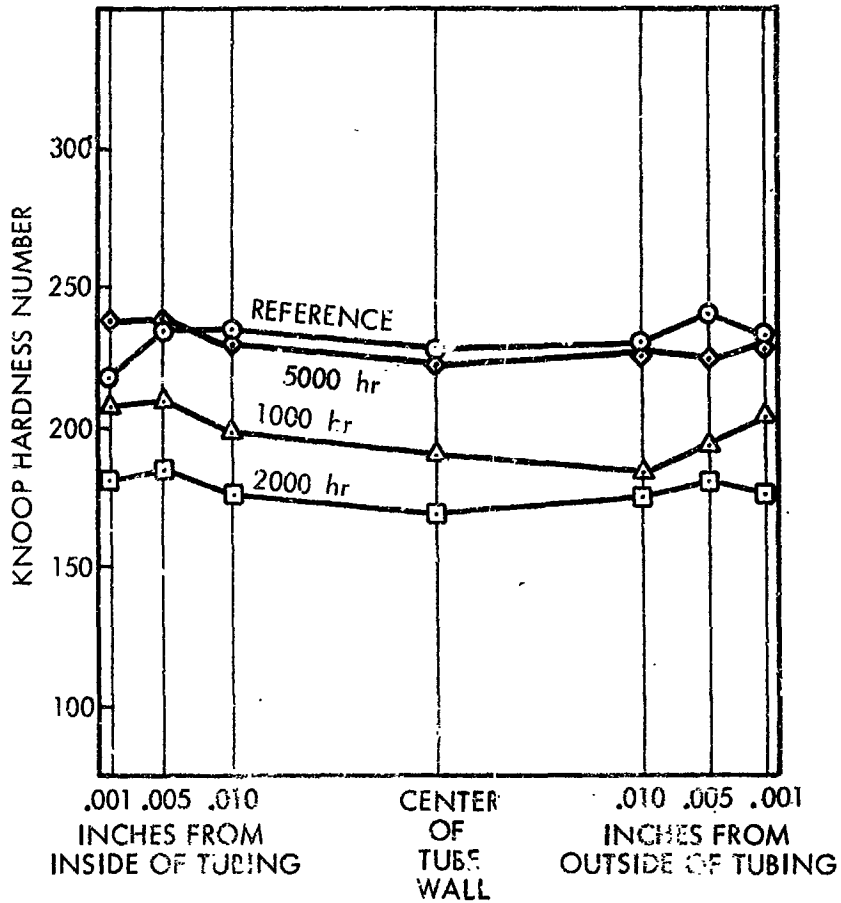
FIGURE 32. MICROHARDNESS SURVEY, TYPE 405 STAINLESS STEEL EXPOSED TO MERCURY AT 1025°F

A summary of microhardnesses is shown in Figures 32 and 33. The capsules with Cb strips are not included.

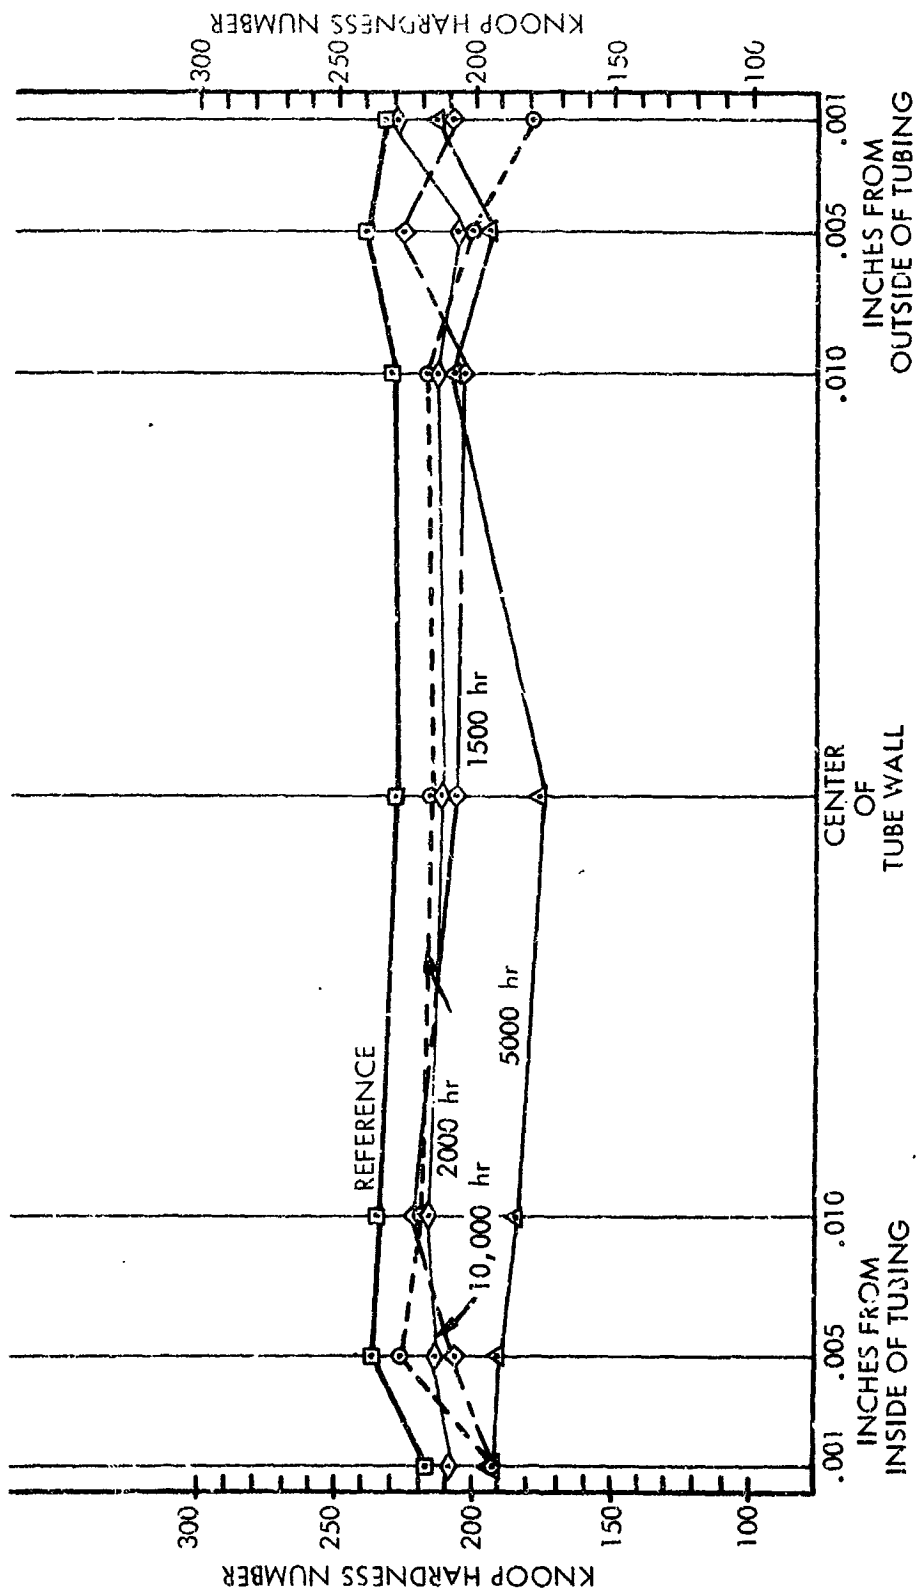
FIGURE 33. MICROHARDNESS SURVEY, TYPE 405 STAINLESS STEEL EXPOSED TO MERCURY AT 1100°F

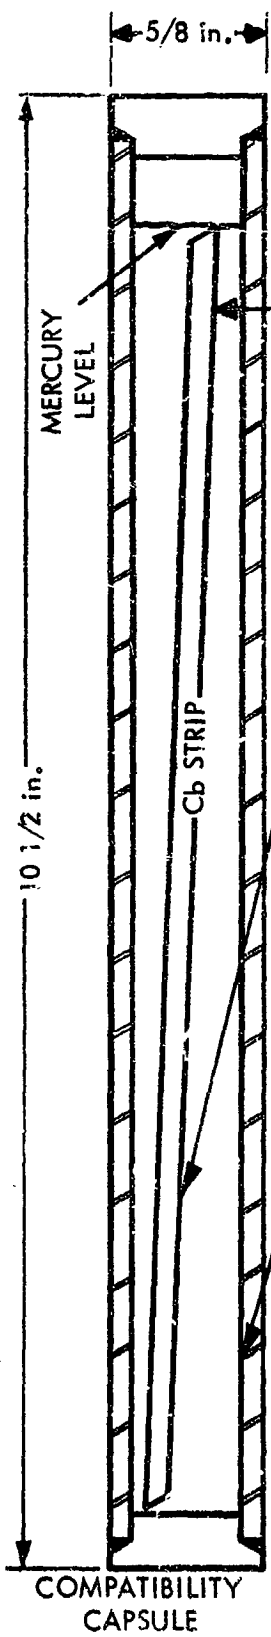
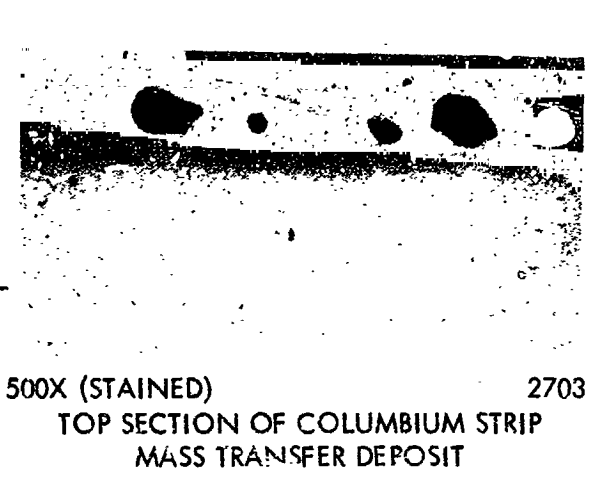
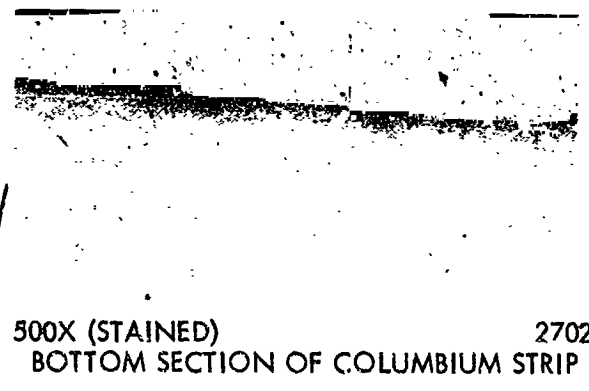
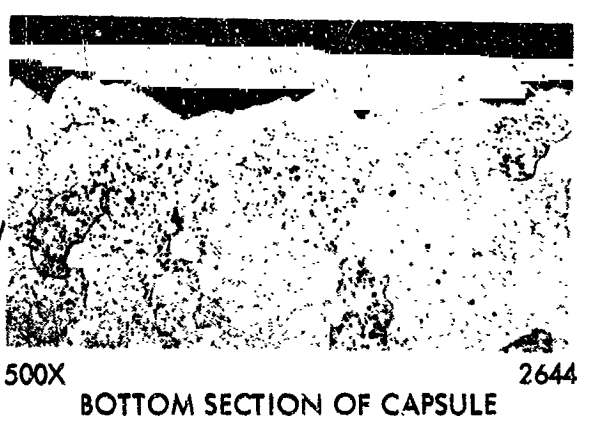
FIGURE 35. 9Cr-1Mo CAPSULE NO. 9AA-71 WITH COLUMBIUM STRIP TESTED AT 1250°F FOR 500 HOURS

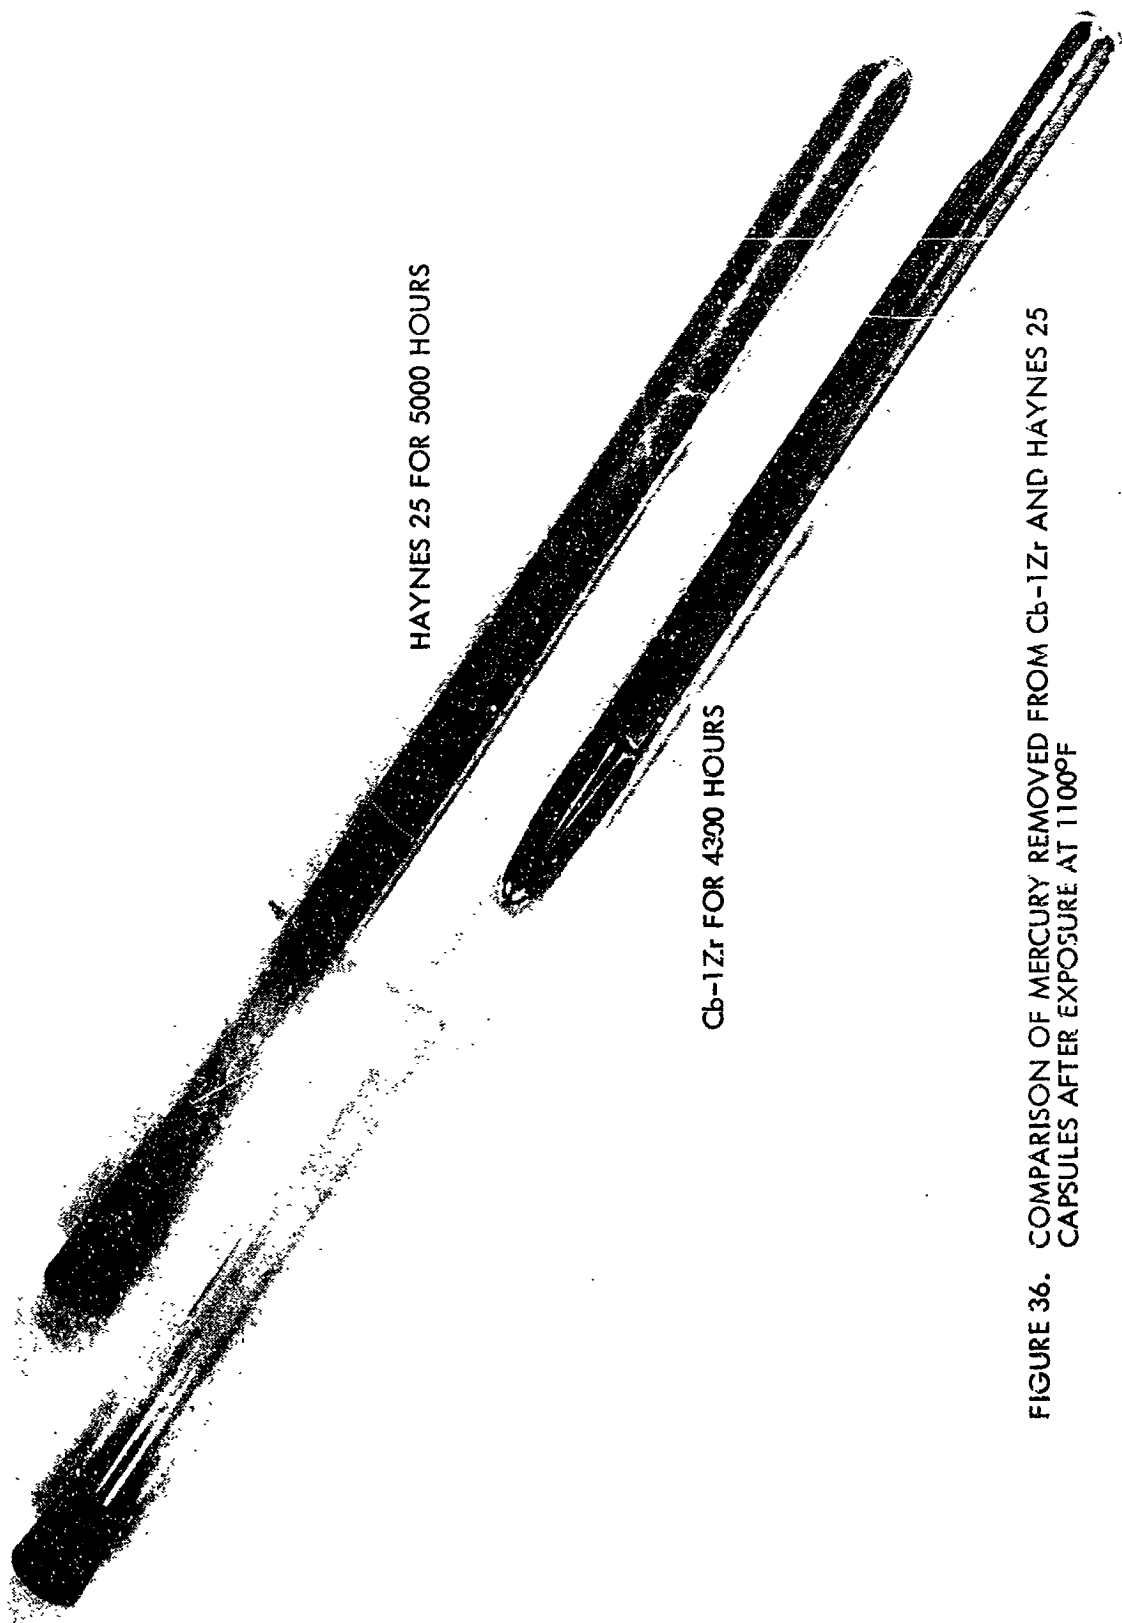
FIGURE 36. COMPARISON OF MERCURY REMOVED FROM Cb-1Zr AND HAYNES 25 CAPSULES AFTER EXPOSURE AT 1100°F

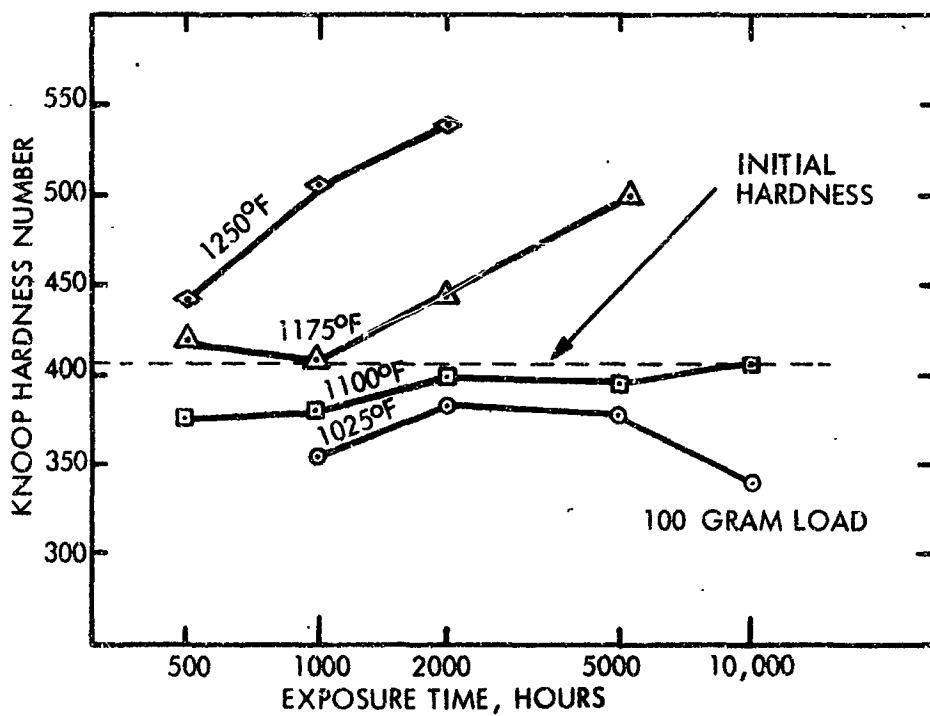
The values obtained from the tensile tests indicate that the mechanical properties of Haynes 25 are affected by age hardening. However, the tensile values are not the same as typical or minimum values obtained for Haynes 25 aged in air at the test temperature. It should be remembered that the tensile specimens machined from compatibility capsules are not standard test specimens and that they have been exposed to Hg; therefore, the values can only be compared with results from tensile tests conducted with the same type of specimens exposed to similar environments.

FIGURE 37. KNOOP HARDNESS VERSUS EXPOSURE TIME FOR HAYNES 25

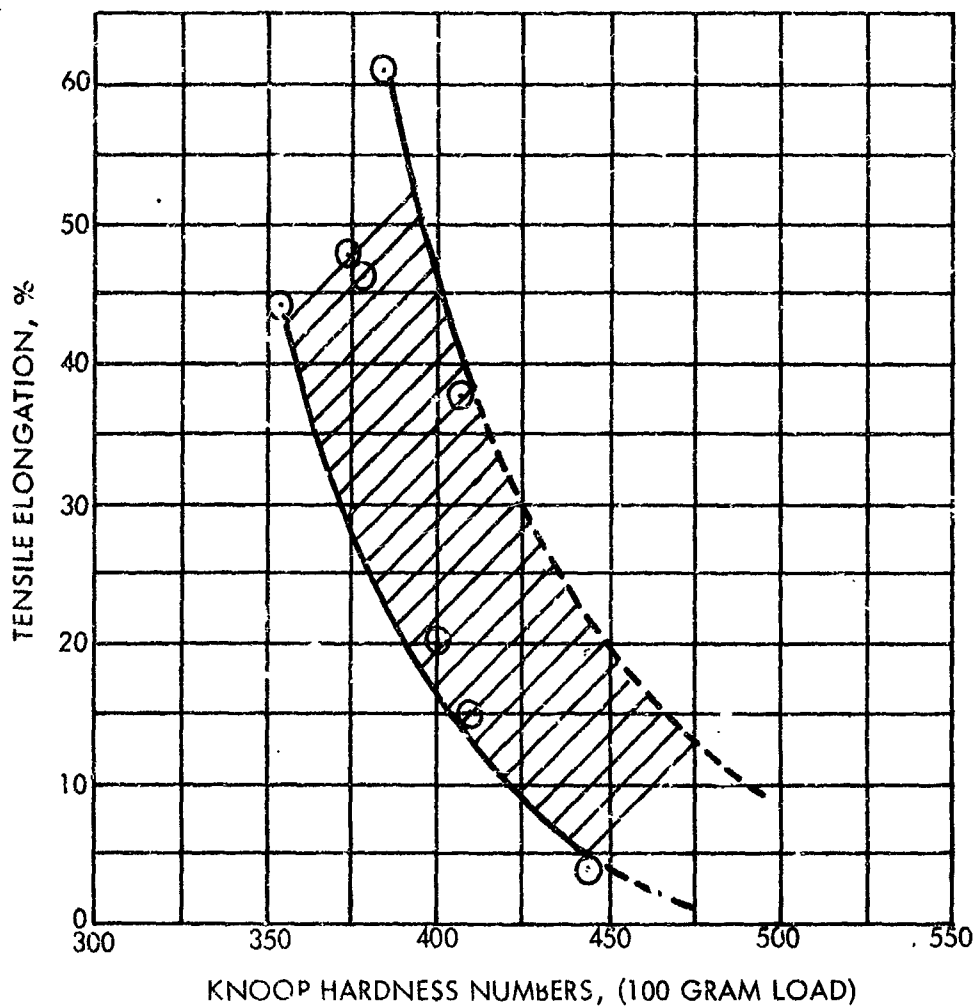
As would be expected, the ductility of Haynes 25 decreases as the hardness increases. Figure 38 is a plot of tensile elongation versus hardness for the compatibility specimens tested. There appears to be poor correlation between tensile elongation and hardness around 400 Knoop; however, the increasing hardness of the Haynes 25 exposed to temperatures of 1175°F and higher is a good indication of loss of room temperature ductility. Age hardening of this alloy, as evidenced in hardness increases and decreases in ductility, does not occur below 1100°F.

FIGURE 38. TENSILE ELONGATION VERSUS KNOOP HARDNESS FOR HAYNES 25 TENSILE TEST SPECIMENS
